New York State Department of Transportation

Yellow Flag NB22CTW015

BIN: 1065318

Feature Carried: 278I278IX2M23027

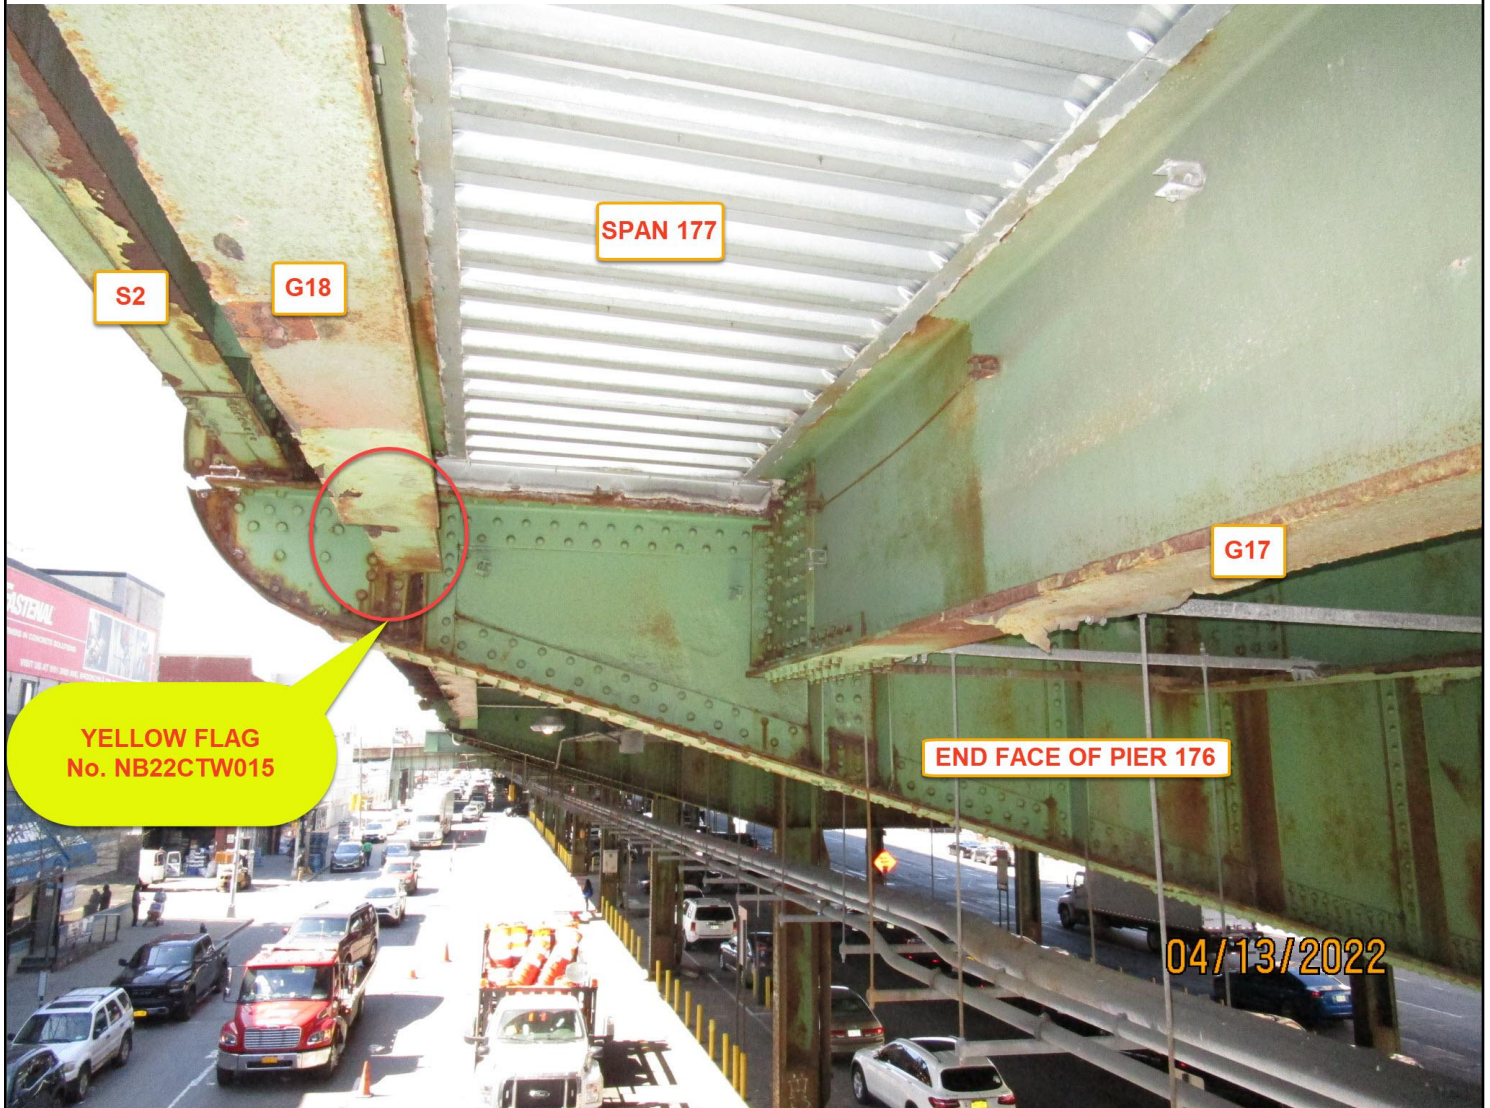
Photo Number: 1

Description: The right connection angle at Girder G18 in Span 177 at Pier 176 exhibits a 9" long (no change since previous inspection) vertical crack along the fillet stemming from the 3"H x 2"L (previously 2"H x 1"L) and a 2"H x 3/4"L (not previously noted) corrosion holes at the bottom of the angle. The girder is framed into the web of the pier with connection angles at both sides of the girder.

Attachment Description: General view of the flagged condition at Girder G18 in Span 177 at Pier 176. Looking Begin.

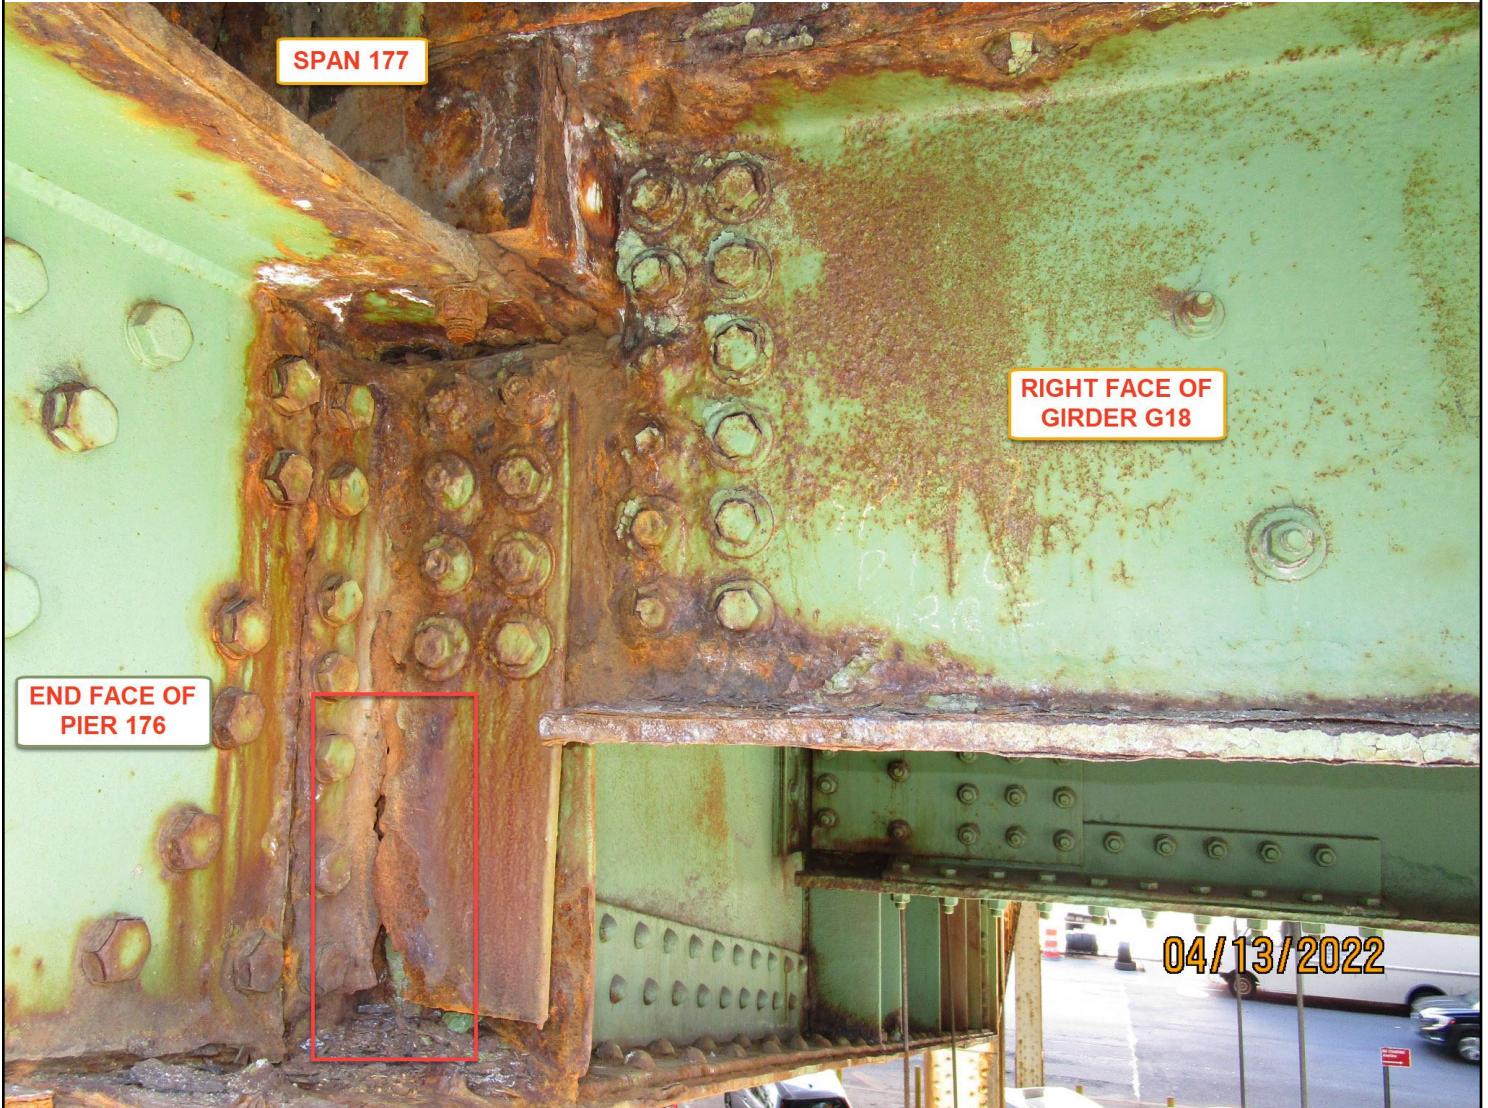
Photo Number: 2

Attachment Description: Close-up general view of the flagged condition at Girder G18 in Span 177 at Pier 176. The boxed area exhibits a corrosion hole vertical crack along the fillet, stemming from the 3"H x 2"L corrosion hole at the bottom of the angle. Looking Left.

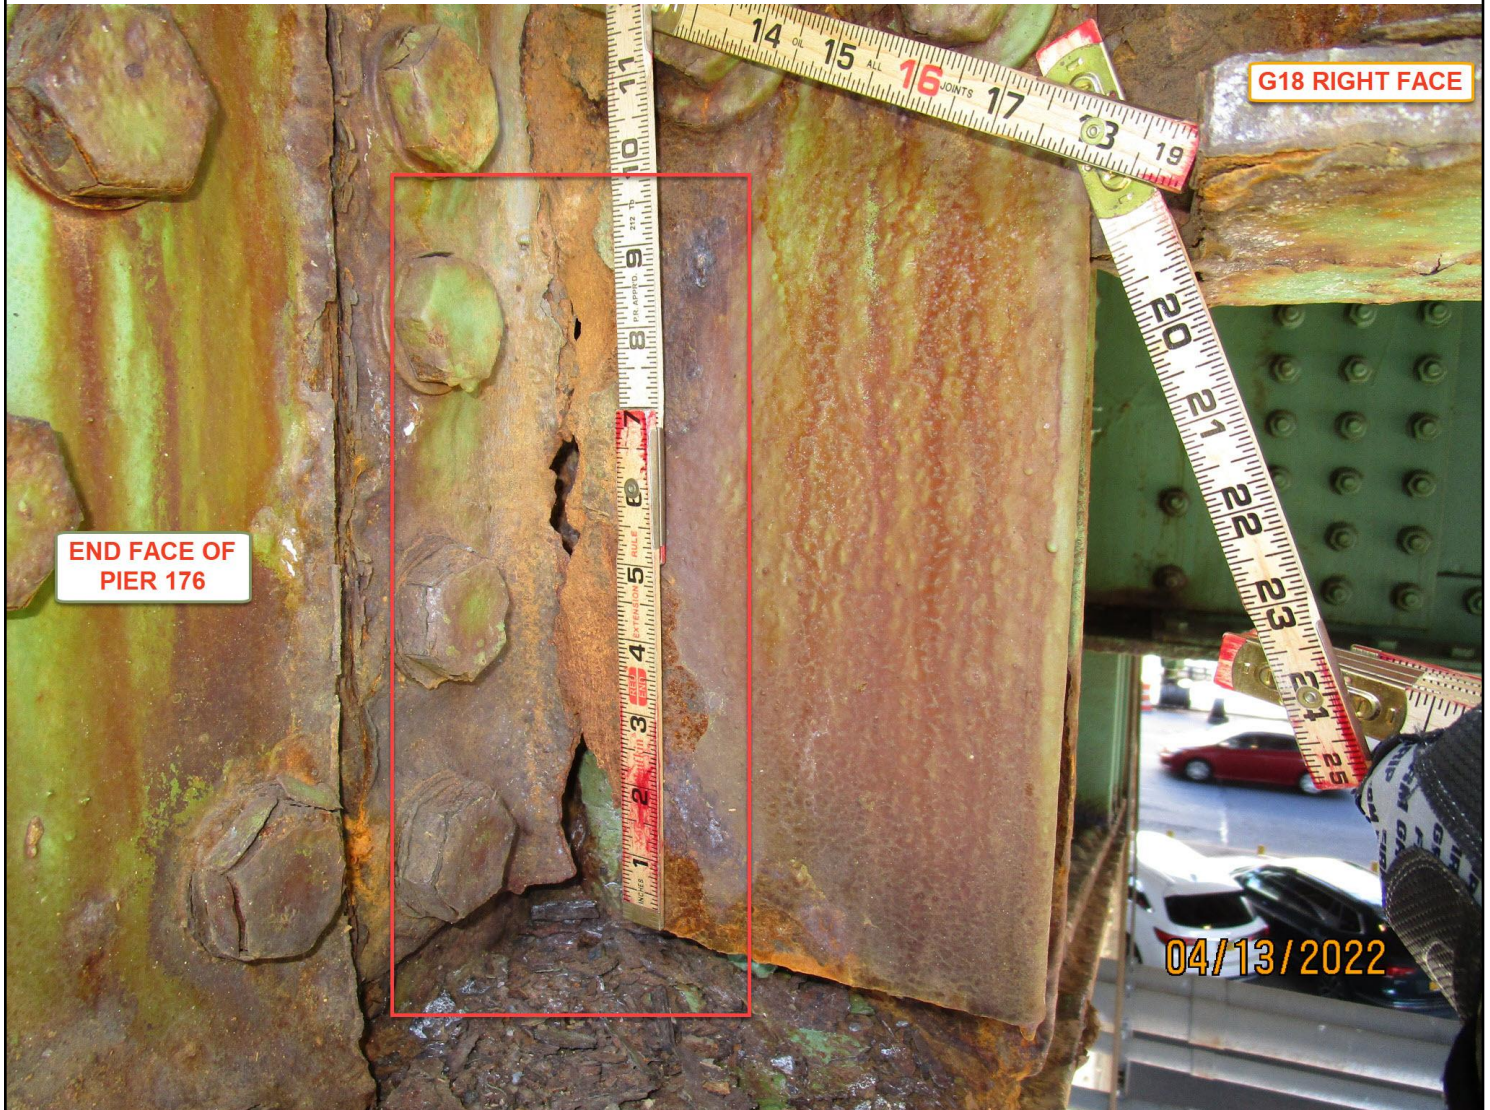
Photo Number: 3

Attachment Description: Closed-up view of the right face of Girder G18 in Span 177 at Pier 176. The connection angle at the girder exhibits vertical crack along the fillet stemming from the 3"H x 2"L corrosion hole at the bottom of the angle. Additionally, there is a 2"H x 3/4"L corrosion hole. Looking Left.

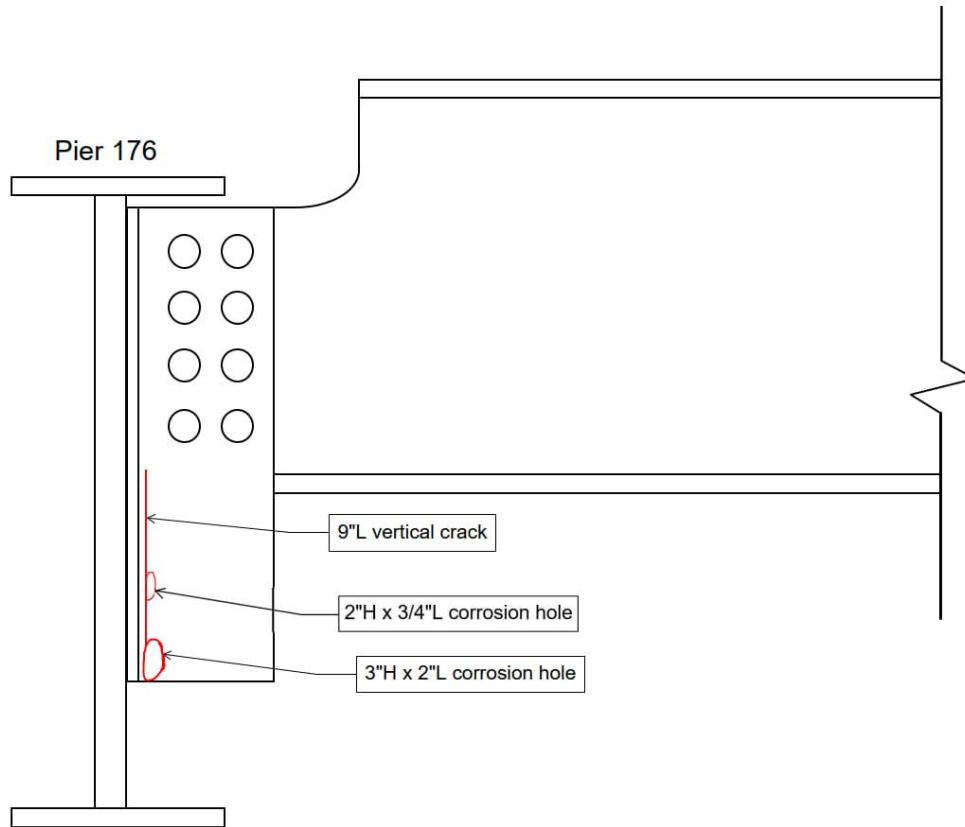
Right Face of Girder G18
in Span 177 at Pier 176
N.T.S.

Attachment Description: SN 177 G18 at Pier 176 Sketch

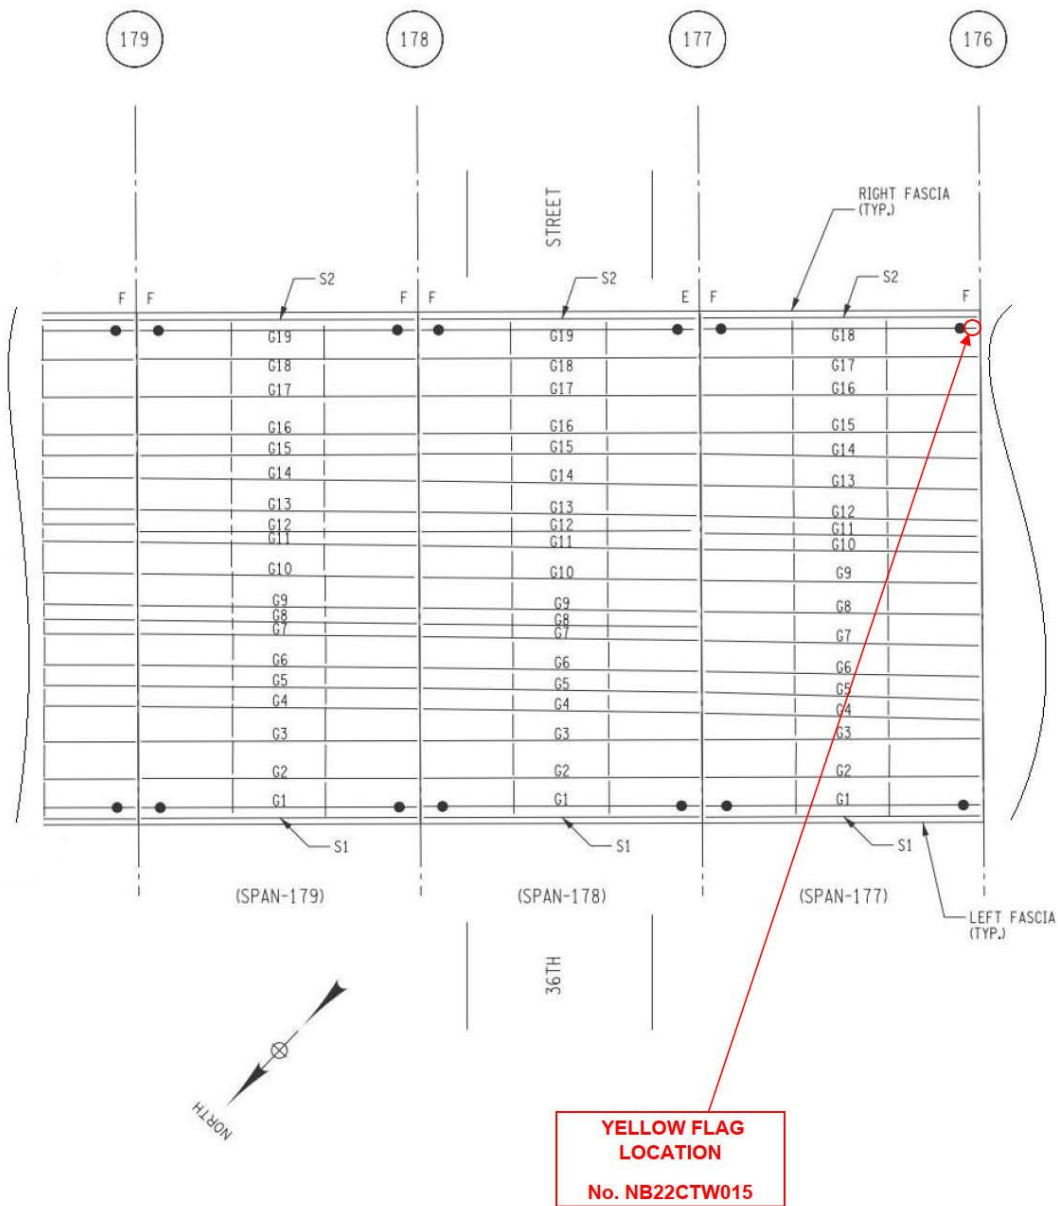
Photo Number: 5

Attachment Description: SN 177 G18 at Pier 176 Framing Plan
